Rotted Beam Repair

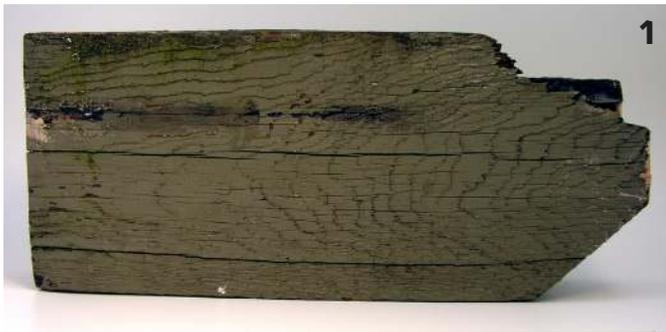
1

The beam end is 18 inches long, 8 inches high and 5 inches thick. The rotted wood has been removed at this stage and borates have been applied. Note that upper right corner and right end have rotted away. The rot extended down into the diagonal cut. Note also the two splits in the wood. The upper one extended through the rotted area to the face on the other side and allowed the far face to be pushed inward. The task is to return the beam back to its original profile as well as rebuild the area where the rot was removed.

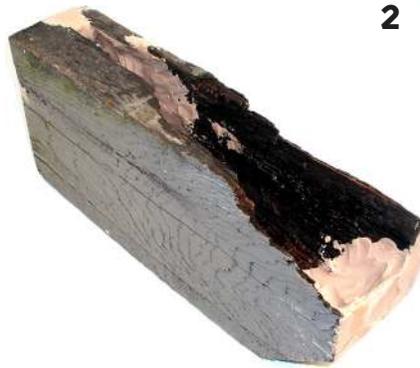
2

RotFix has been lavishly applied to all the rotted areas. Its low viscosity allows it to seep into all the cracks. When the RotFix was still slightly tacky SculpWood Putty was used to “dam up” the ends. We used a couple of our large plastic squeegees to establish the beam ends. These were duct taped into place and SculpWood Putty was packed against it. We used the putty to make large fillets to support the newly created partial face on the diagonal end shown. The putty on the inside towards the back was used to secure the floppy side caused by the crack mentioned above. We used a couple of stir sticks held in place with push pins to set the floppy face to the correct width. The putty fillet in front stabilizes the forward end of the floppy side.

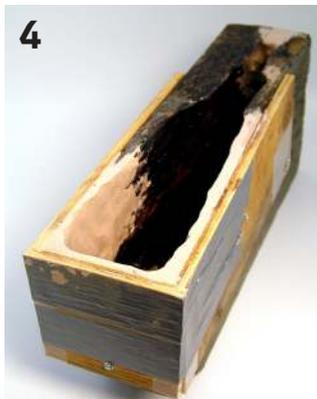
4

This shows how the top edge and upper corners are re-established using plywood mold boards. The mold boards are covered with 2 inch wide packaging tape to act as a release for the applied SculpWood putty. The boards are affixed with hex head wood screws. Duct tape is used to hold the upper part of the end board to the side boards. Note that the top edge of the boards lies right at where the top edge of the rotted beam once was. This is achieved by using the remaining edge of the beam as seen in the rear portion of the photograph. About a half inch of SculpWood Putty has been applied to the shiny side of the packaging tape. (The sticky side is against the plywood.) The top part of the putty was applied slightly above the plywood edge and then sanded flush to establish the new edge. The plywood can be removed after sanding.

We left it on for the next step.

The cut 2 x 4's will be used along with SculpWood putty to fill the interior.

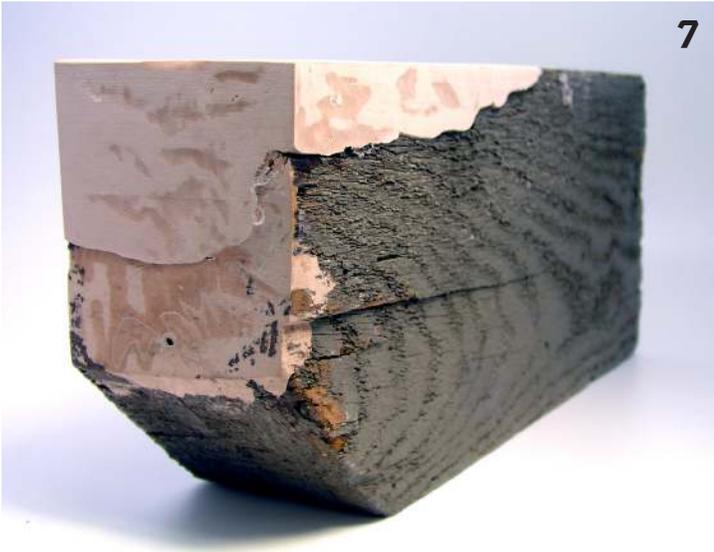
The plywood mold boards have now been removed and the SculpWood sanded to “clean it up” The edges on the sides and end of the beam exist because the beam was slightly concave. These will be “faired” in later using SculpWood Paste. Note the split in the forward part of the beam. This is the extension on the crack mentioned in Photo 1.

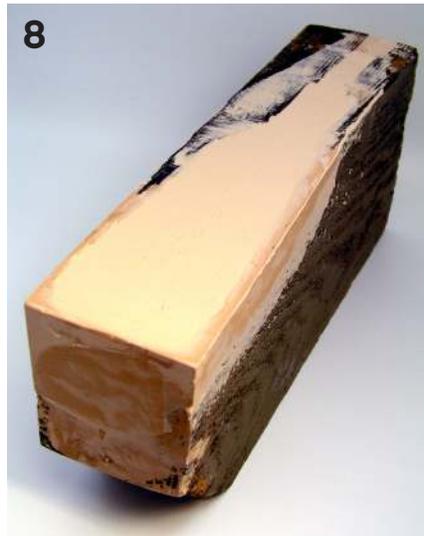
The slight recess in the top has been filled with SculpWood Paste using the newly formed edges as a guide. The side edges have been faired in.

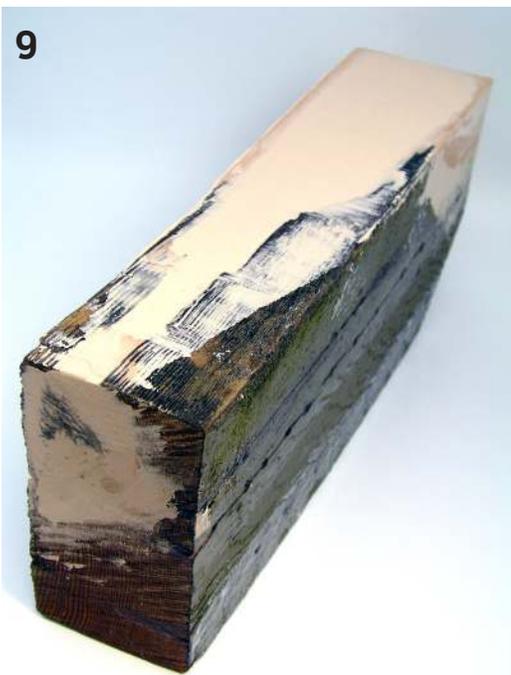
Same repair state as Photo 8. Note the line of holes that have been drilled along the crack. These were sized such that the mixer tip of a cartridge of SilverTip GelMagic adhesive could be seated in the hole allowing GelMagic to be injected into the crack. This both sealed the crack and bonded the two sides together. At this point all the strength has been returned to the beam.

The beam is ready for painting. As an additional step, you can use SculpWood Paste as a surfacing layer to add some texture to the beam. The paste could be allowed to cure to the “green state” and then be carved or otherwise patterned. In our situation this did not matter.
